**NASA CONTRACTOR  
REPORT**

NASA CR-2884

**LOAN COPY: RETURN TO  
AFWL TECHNICAL LIBRARY  
KIRTLAND AFB, N. M.****MODEL PREDICTIONS OF WIND  
AND TURBULENCE PROFILES  
ASSOCIATED WITH AN ENSEMBLE  
OF AIRCRAFT ACCIDENTS**

AERONAUTICAL RESEARCH ASSOCIATES OF PRINCETON, INC.

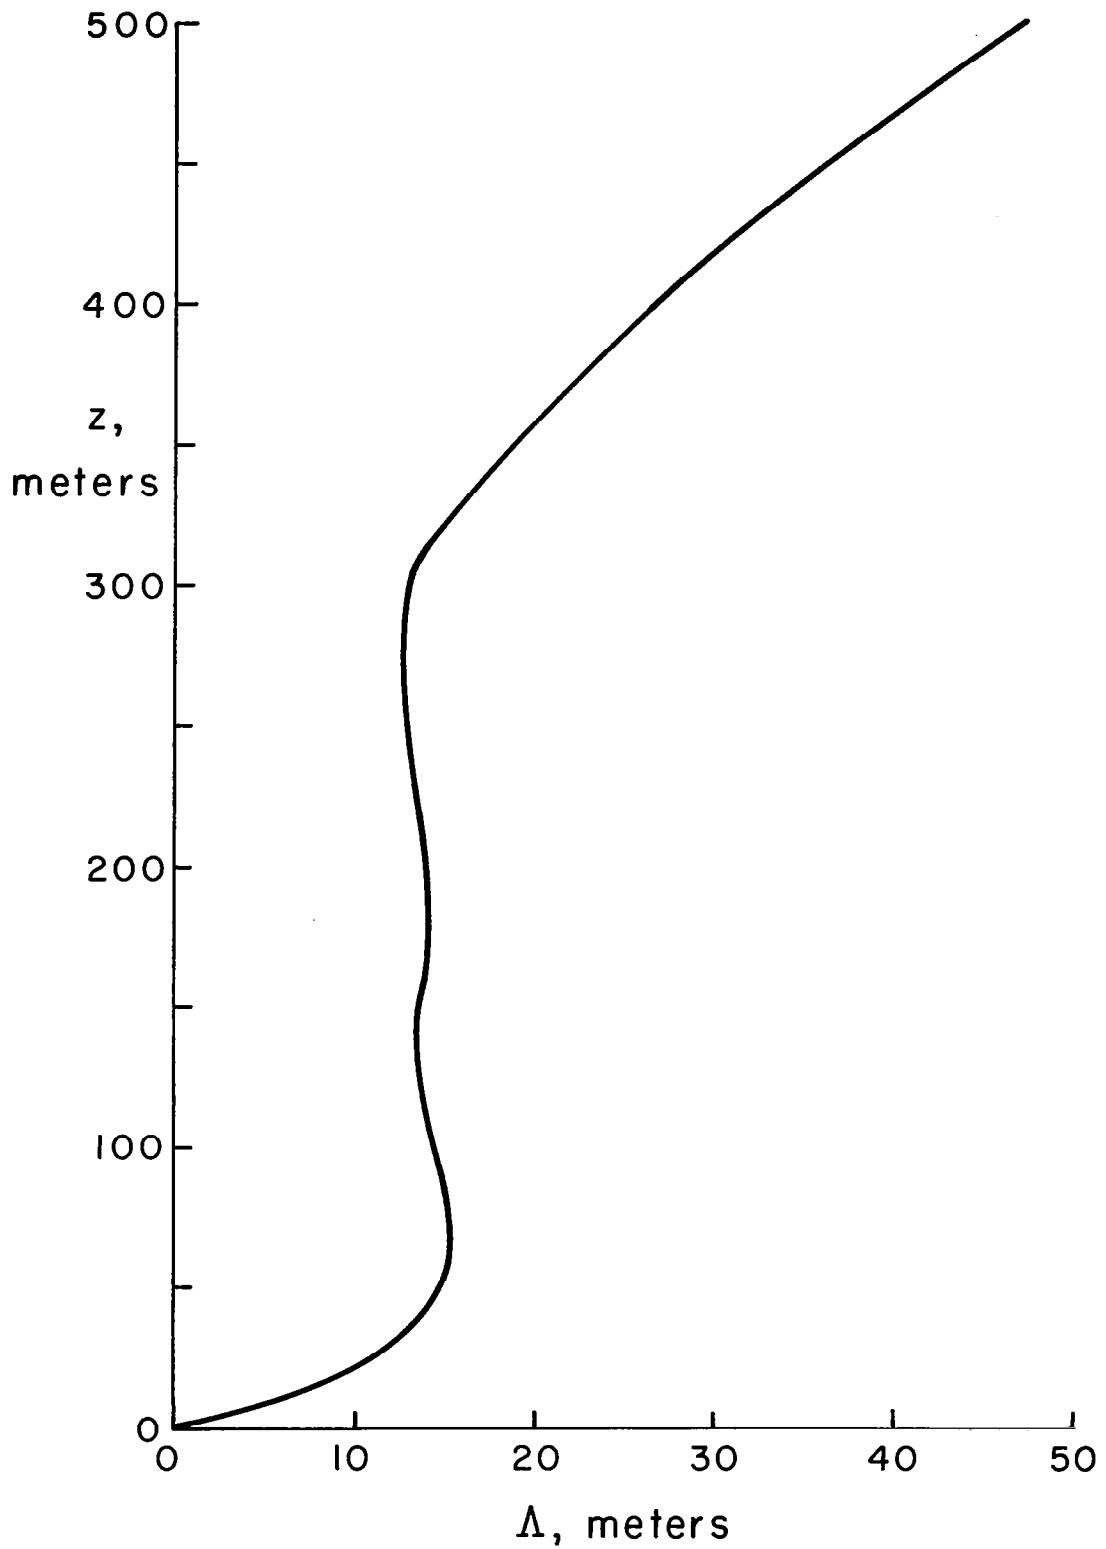
Figure 3.3.13. Altitude profile of scale of turbulence for La Guardia Airport, January 4, 1971 accident.

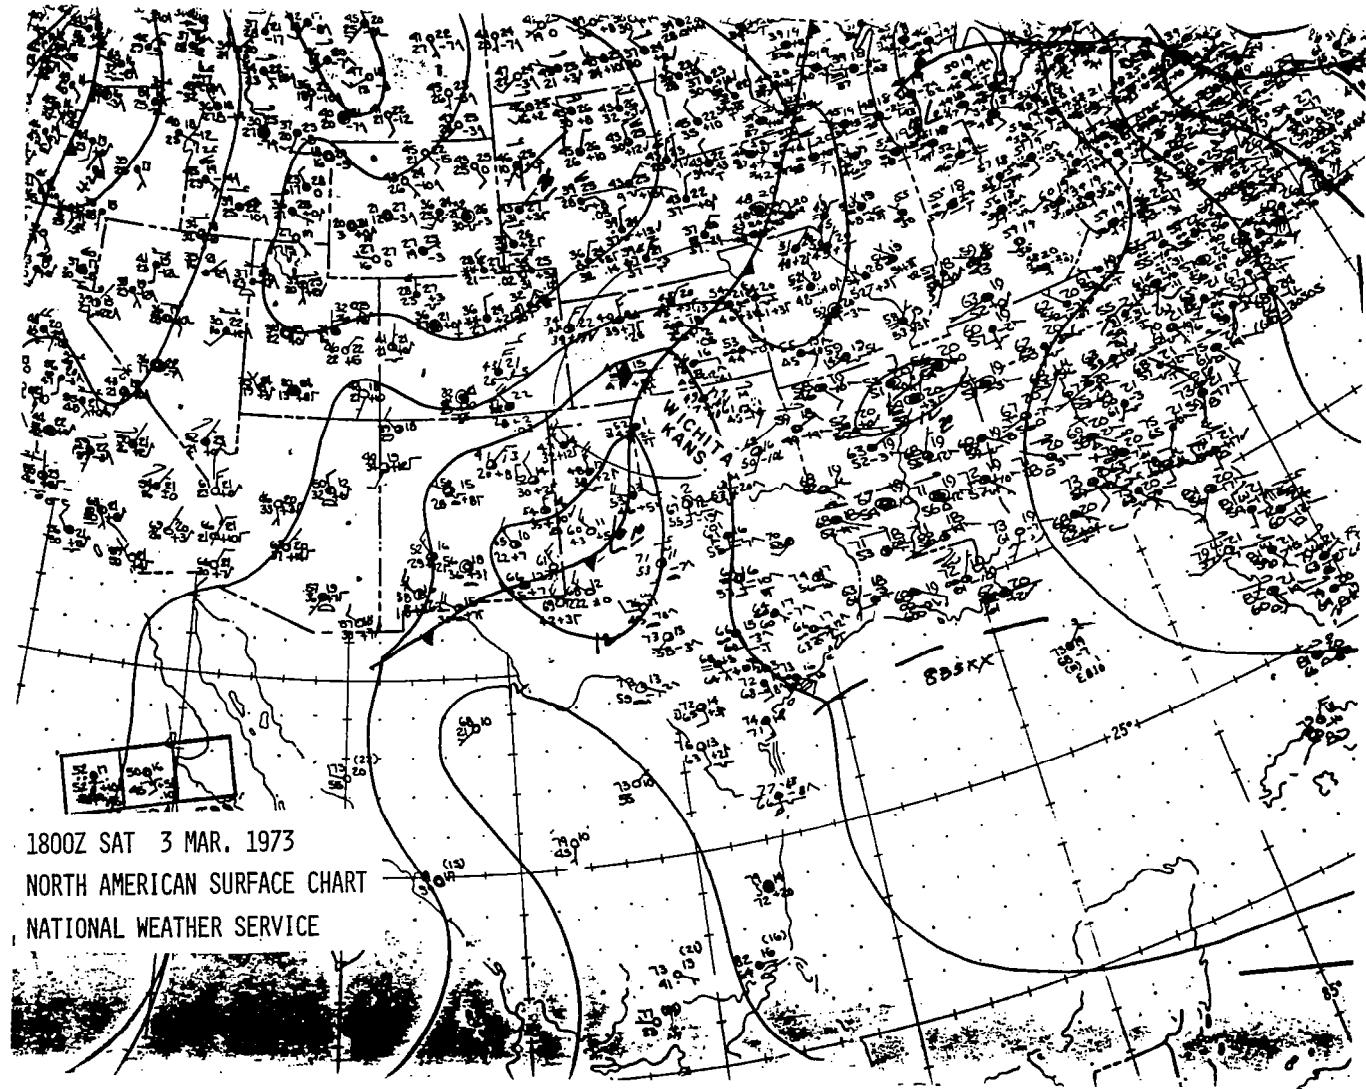
Figure 3.4.4. Early surface weather chart for Wichita, Kansas, March 3, 1973 accident.

Rain showers and thunderstorms were observed in the vicinity both during and prior to the accident. These were associated with a cold front moving in a southeasterly direction across the airport at the time of the accident. (Figures 3.4.2 - 3.4.5.) The flight recorder malfunctioned during landing and no wind profiles were estimated from the data.

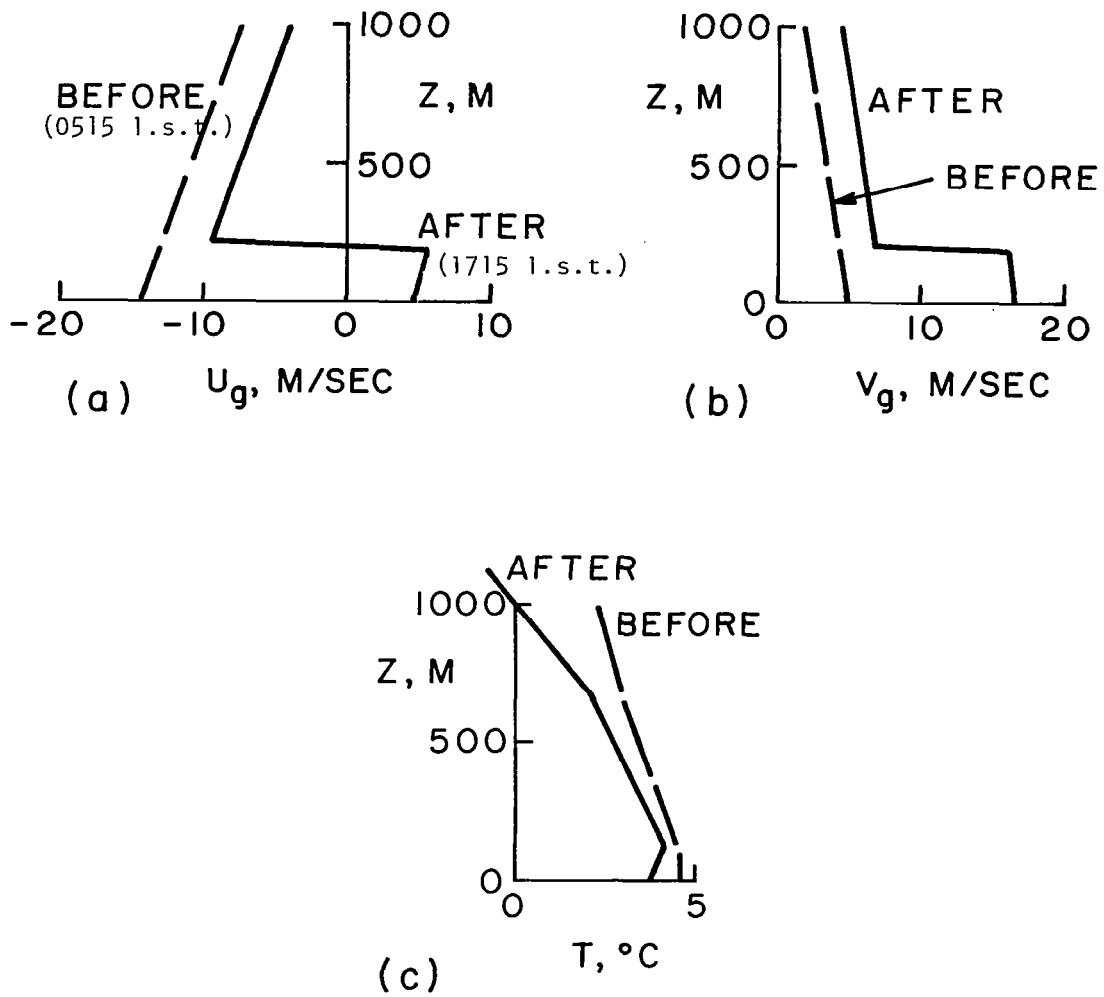
Figure 3.4.6. Altitude profiles for; a) mean geostrophic velocity component parallel to runway (+  $U_g$ , tailwind), b) mean wind velocity component perpendicular to runway (+  $V_g$ , crosswind from right), c) temperature before and after the Wichita, Kansas, March 3, 1973 accident.

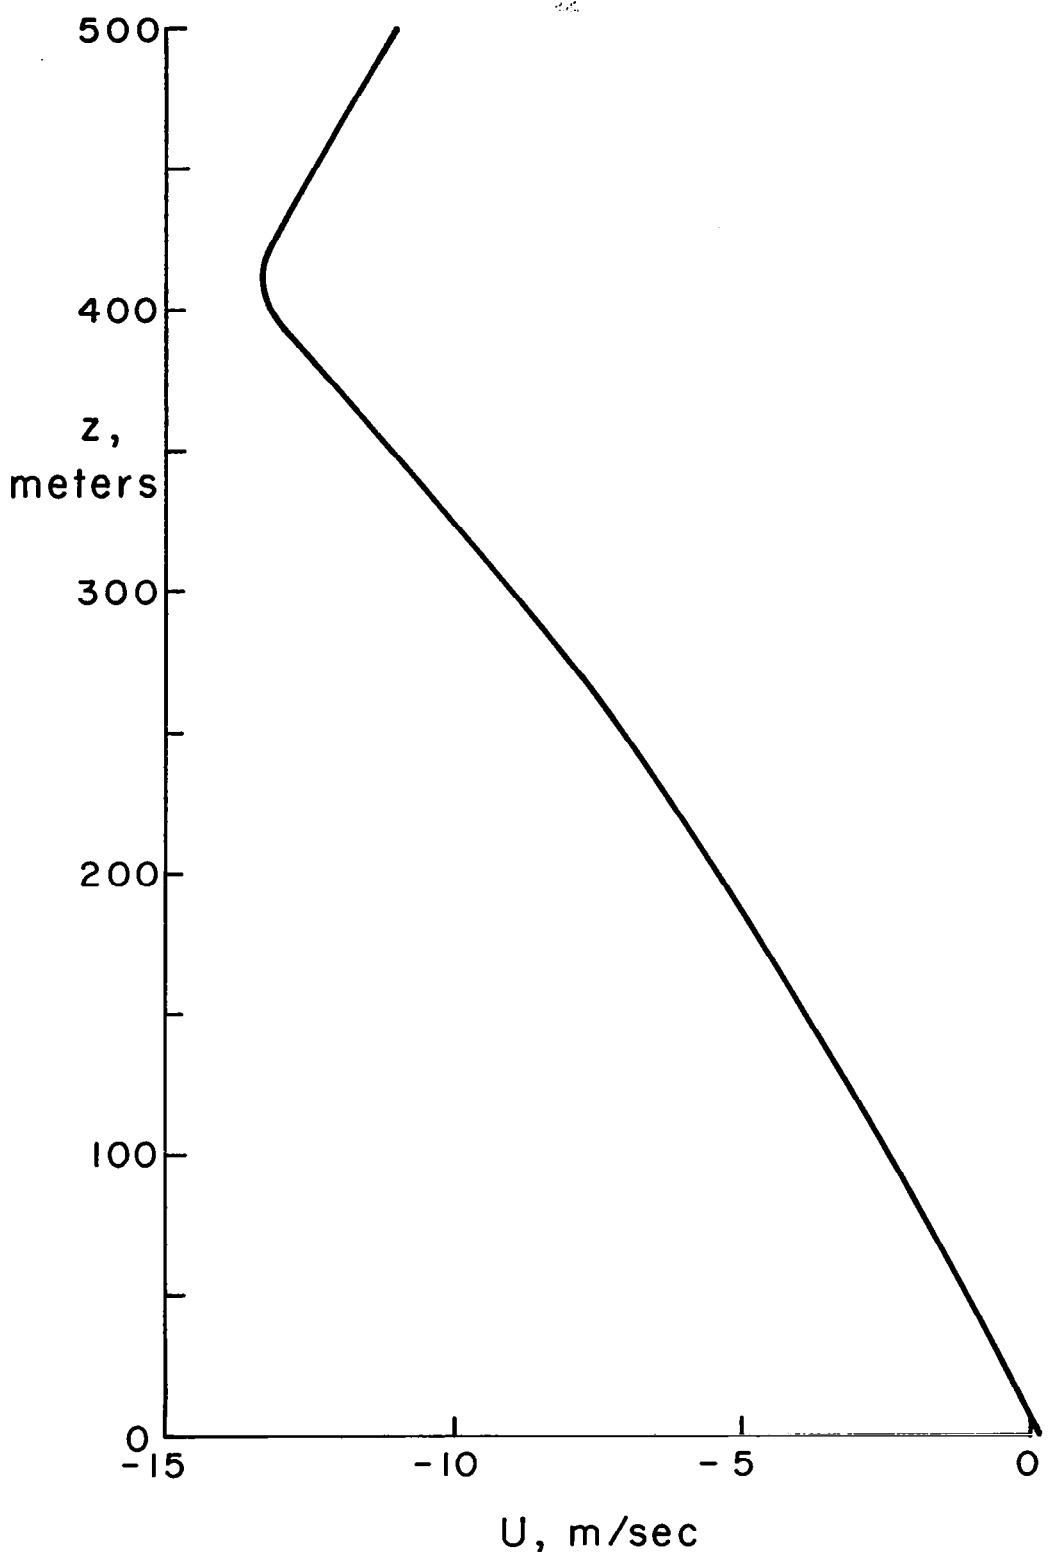
Figure 3.4.7. Altitude profile of mean wind velocity component parallel to runway for the Wichita, Kansas, March 3, 1973 accident.

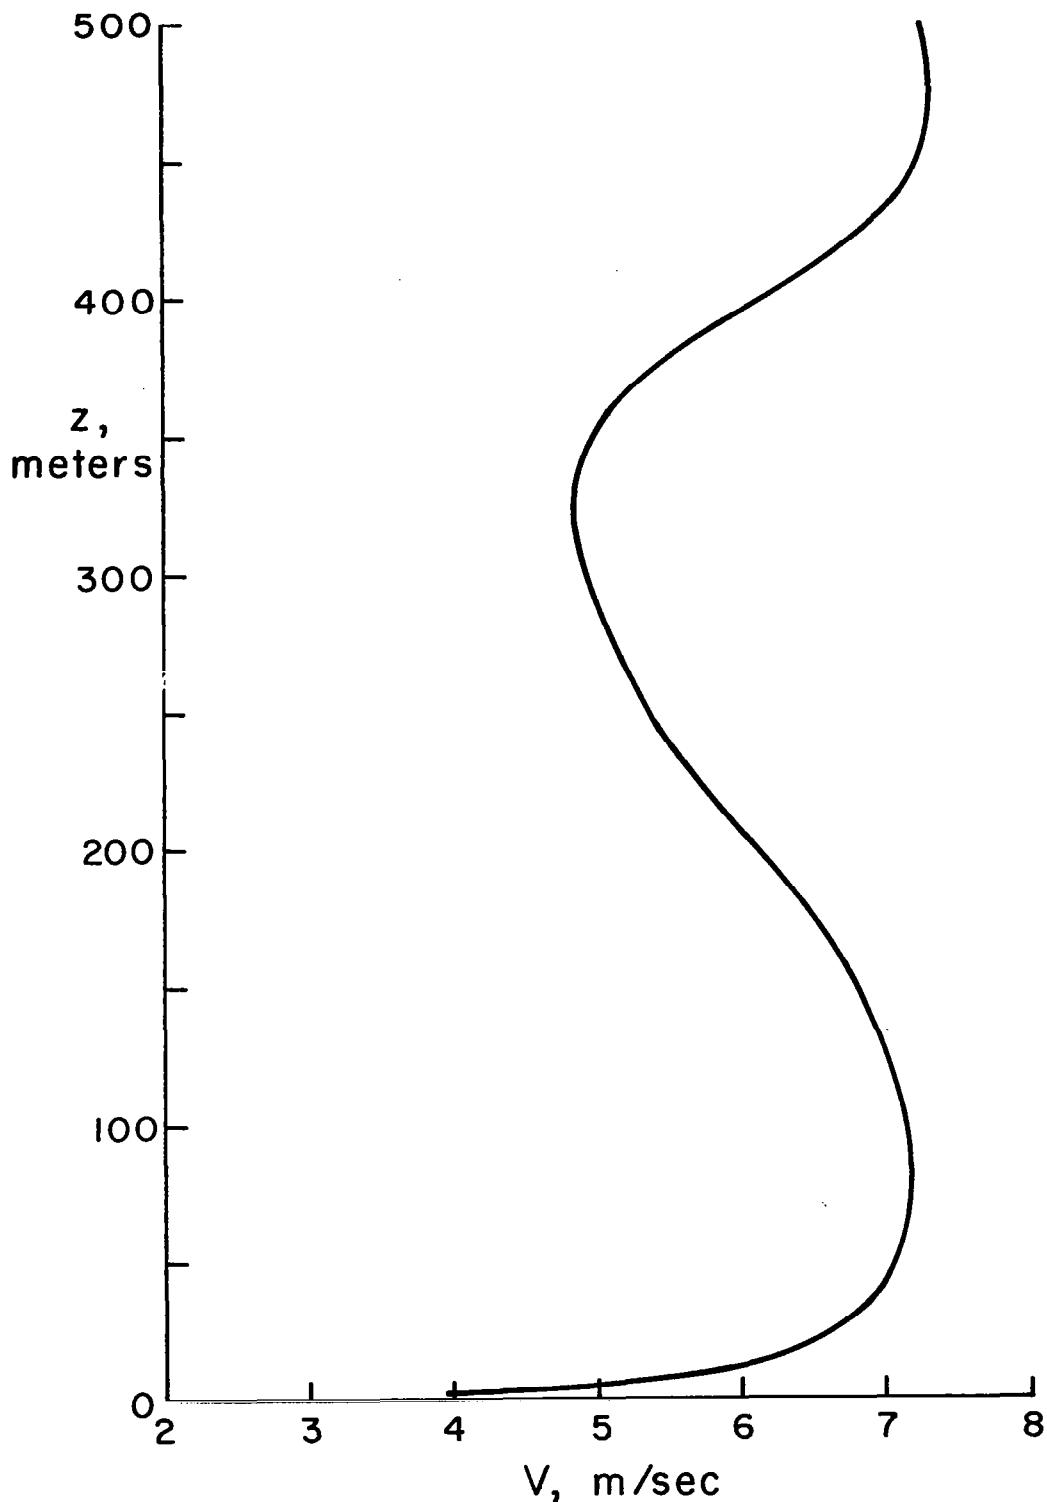
Figure 3.4.8. Altitude profile of mean wind velocity component perpendicular to runway for the Wichita, Kansas, March 3, 1973 accident.

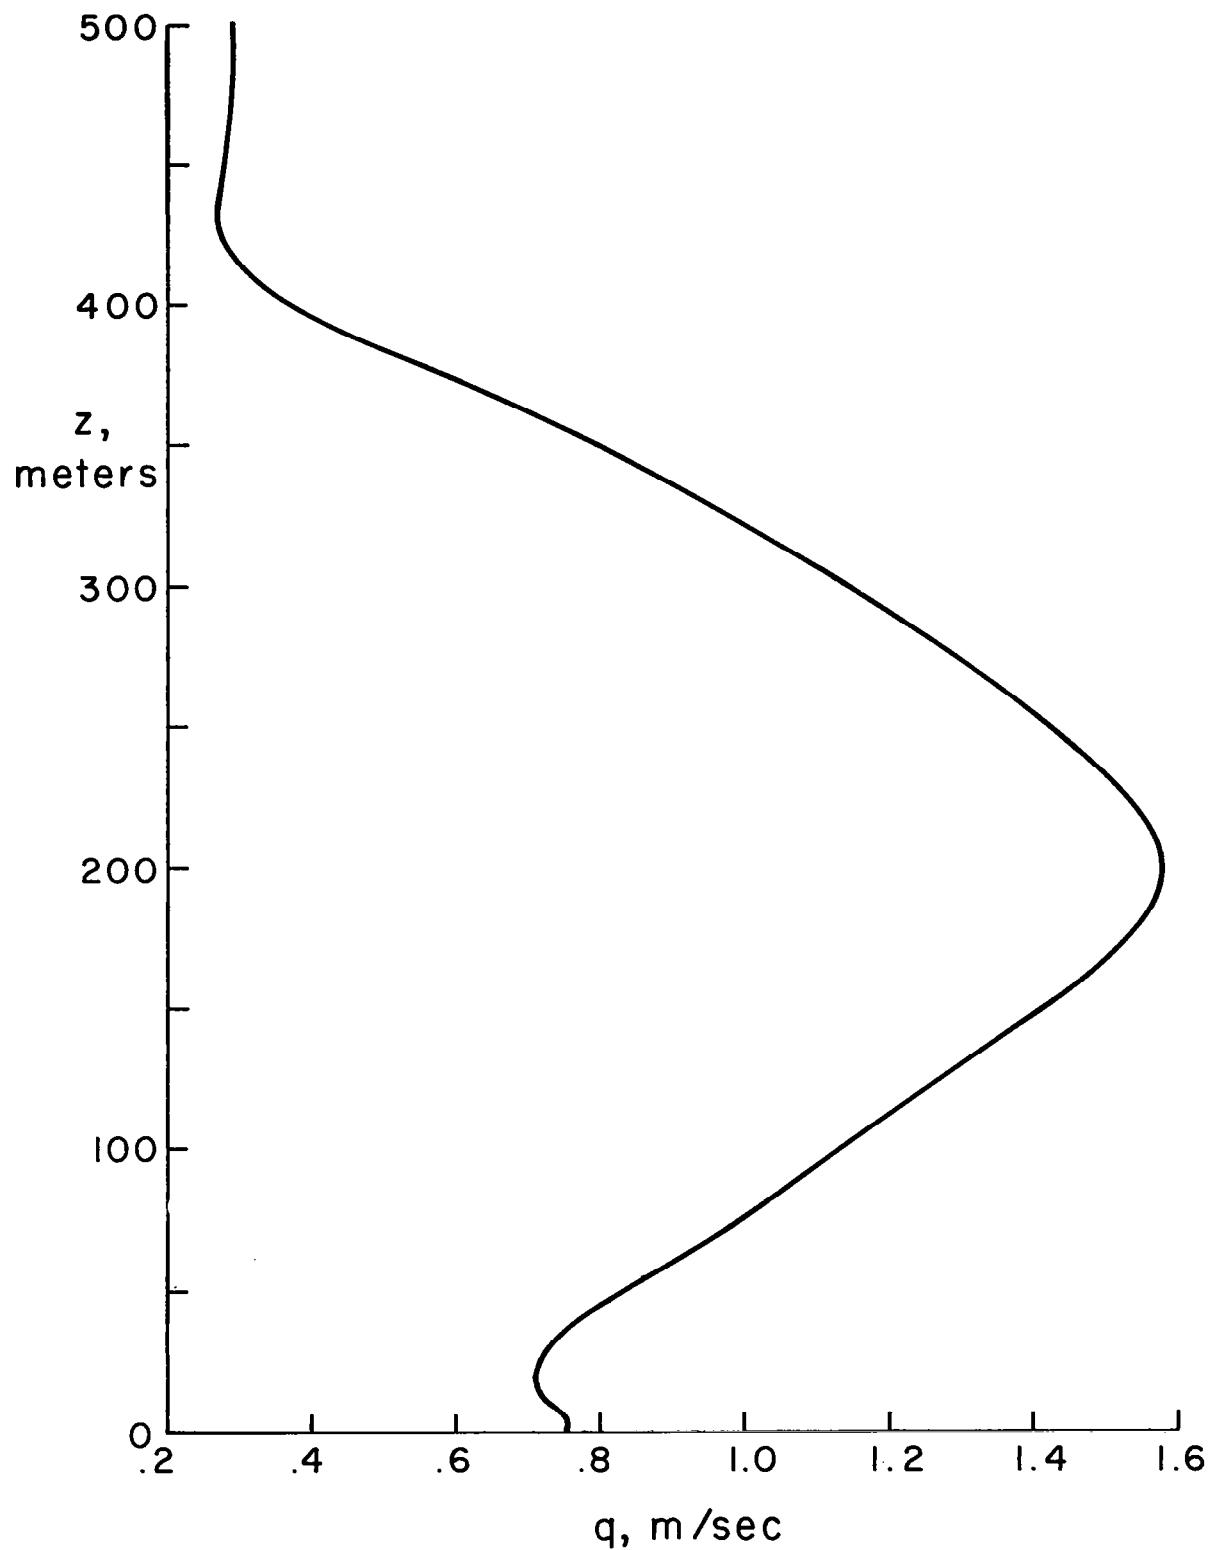
Figure 3.4.9. Altitude profile of variance of the total velocity variance for Wichita, Kansas, March 3, 1973 accident.

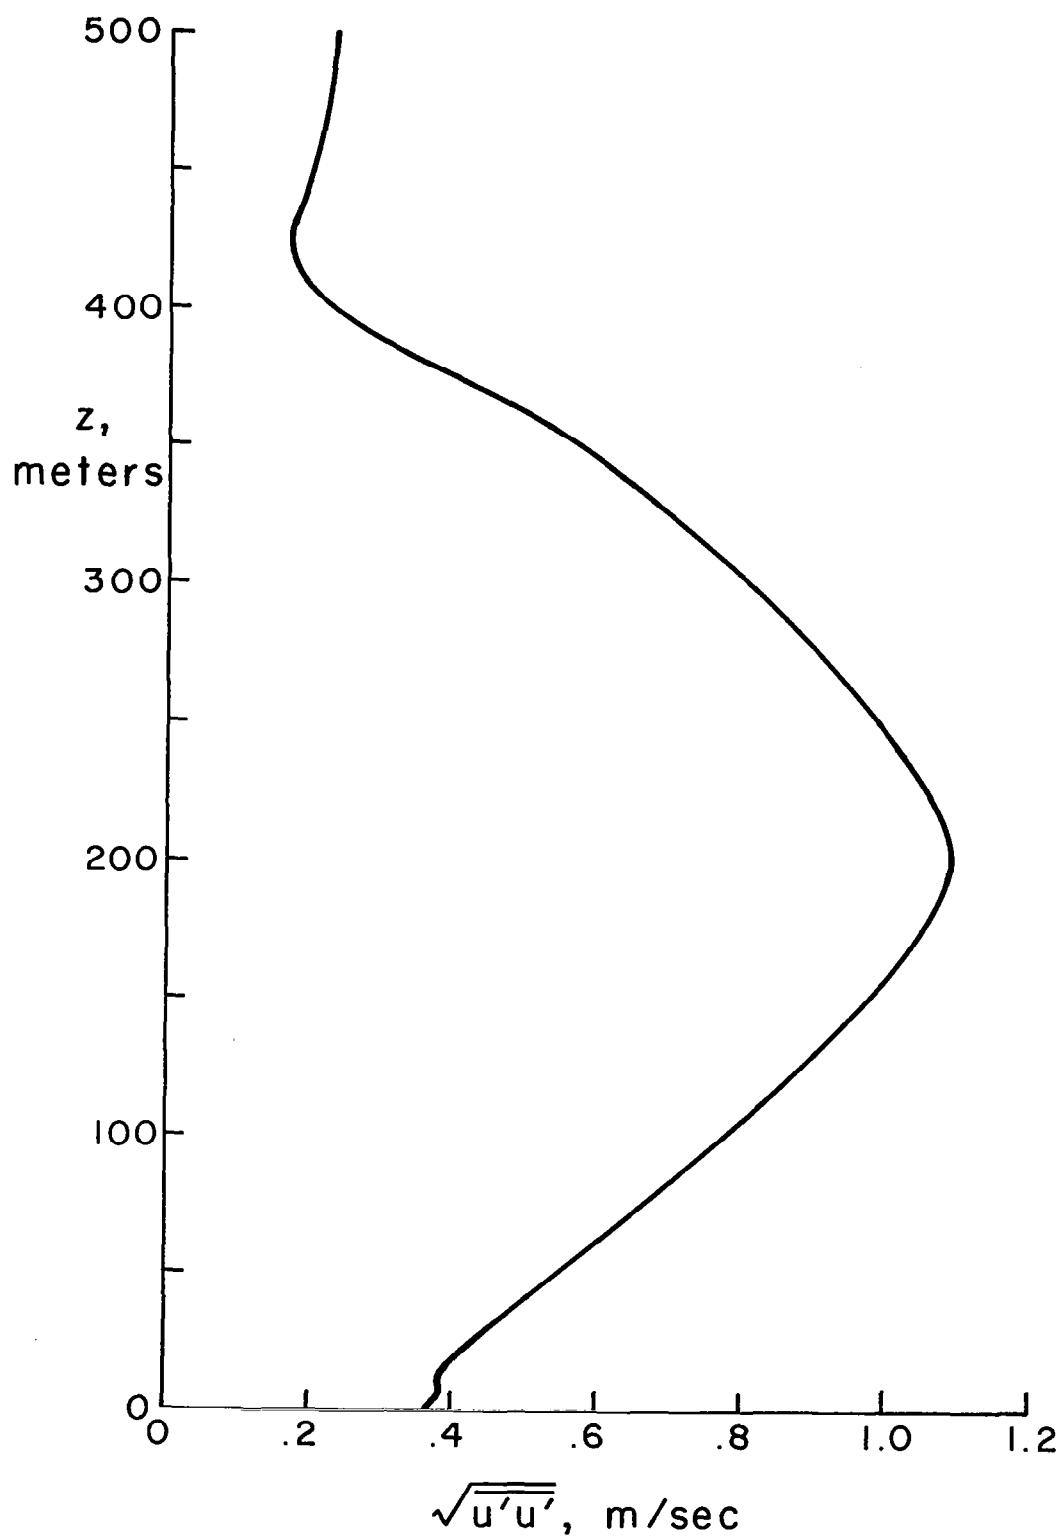
Figure 3.4.10. Altitude profile of variance of the wind parallel to runway for Wichita, Kansas, March 3, 1973 accident.

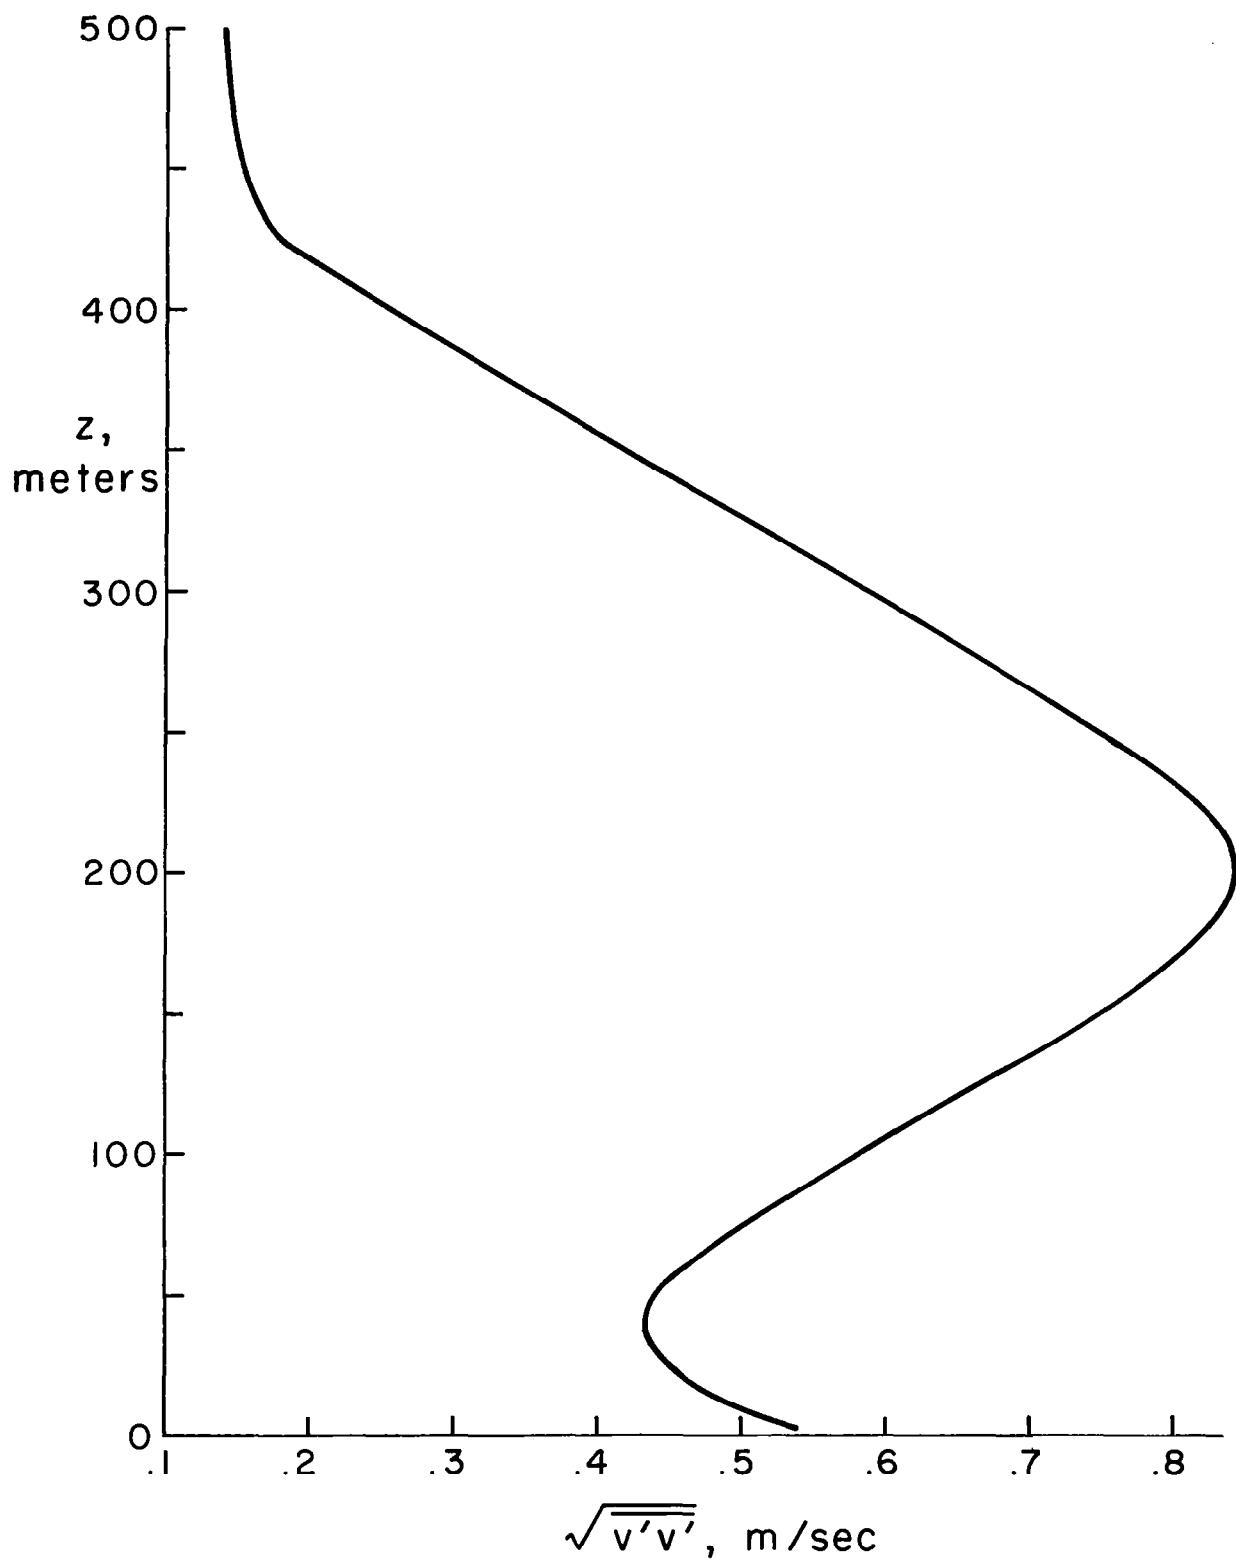
Figure 3.4.11. Altitude profile of variance of the wind perpendicular to runway for Wichita, Kansas, March 3, 1973 accident.

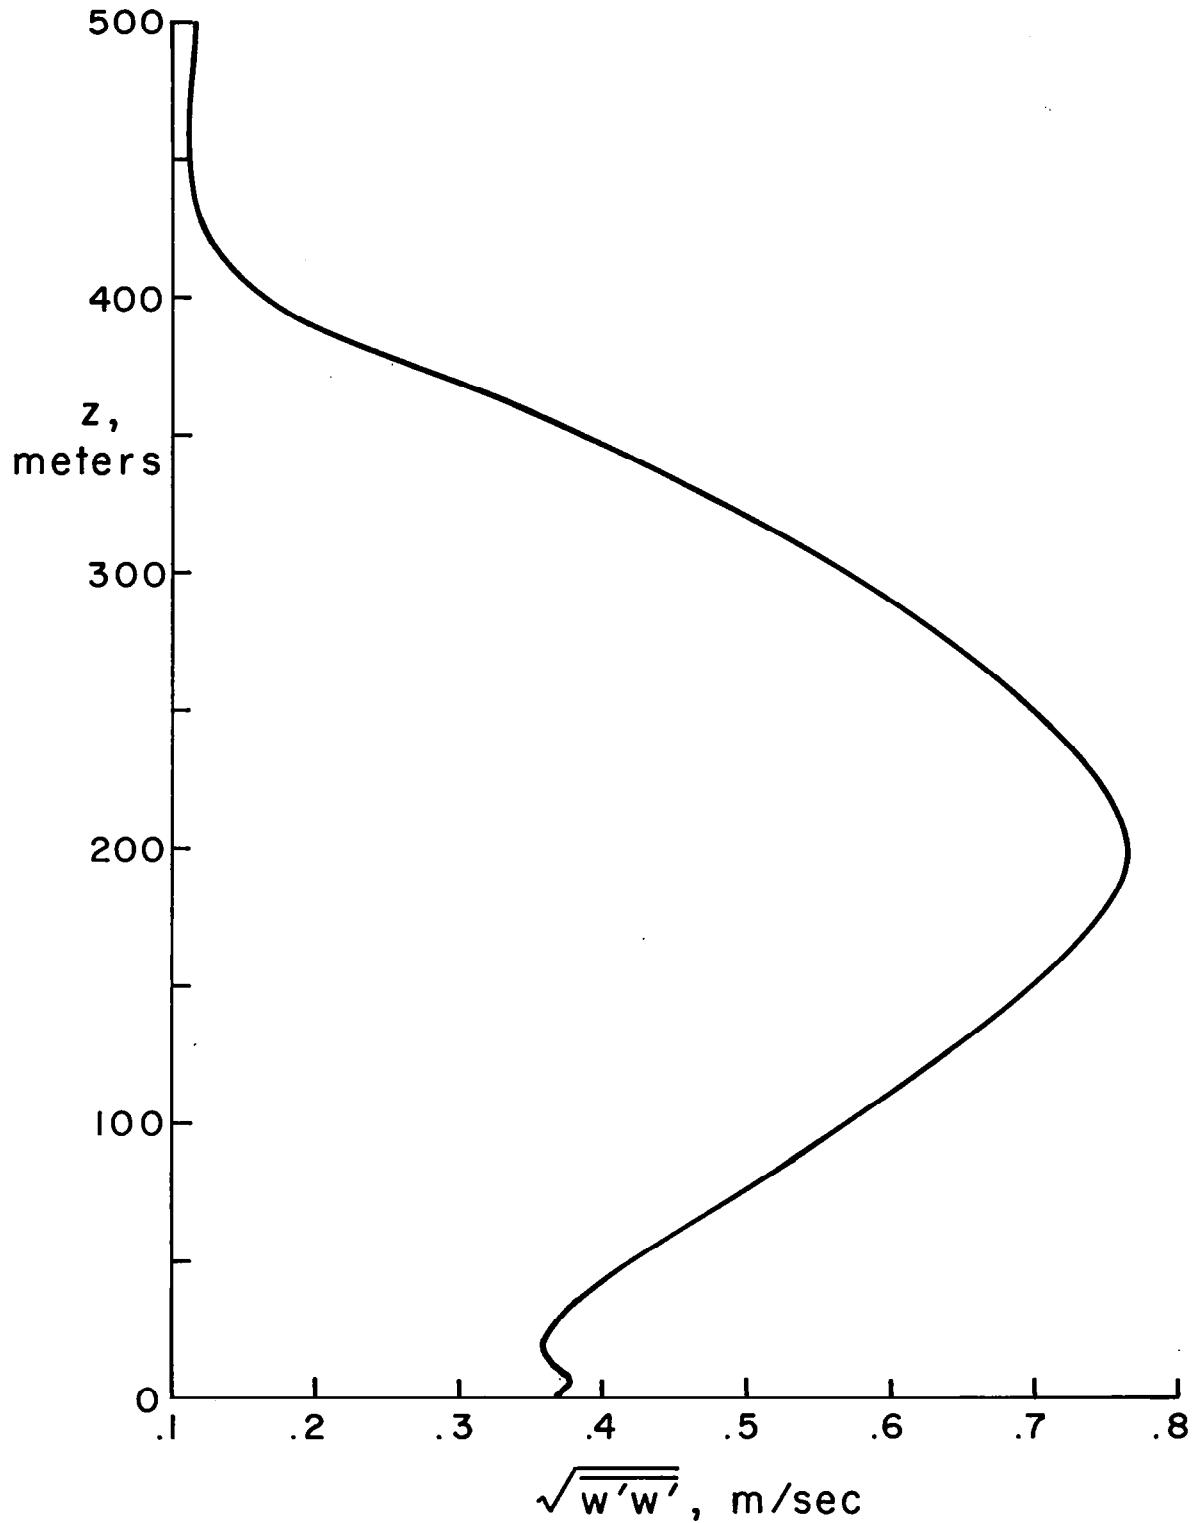
Figure 3.4.12. Altitude profile of variance of the vertical wind for Wichita, Kansas, March 3, 1973 accident.

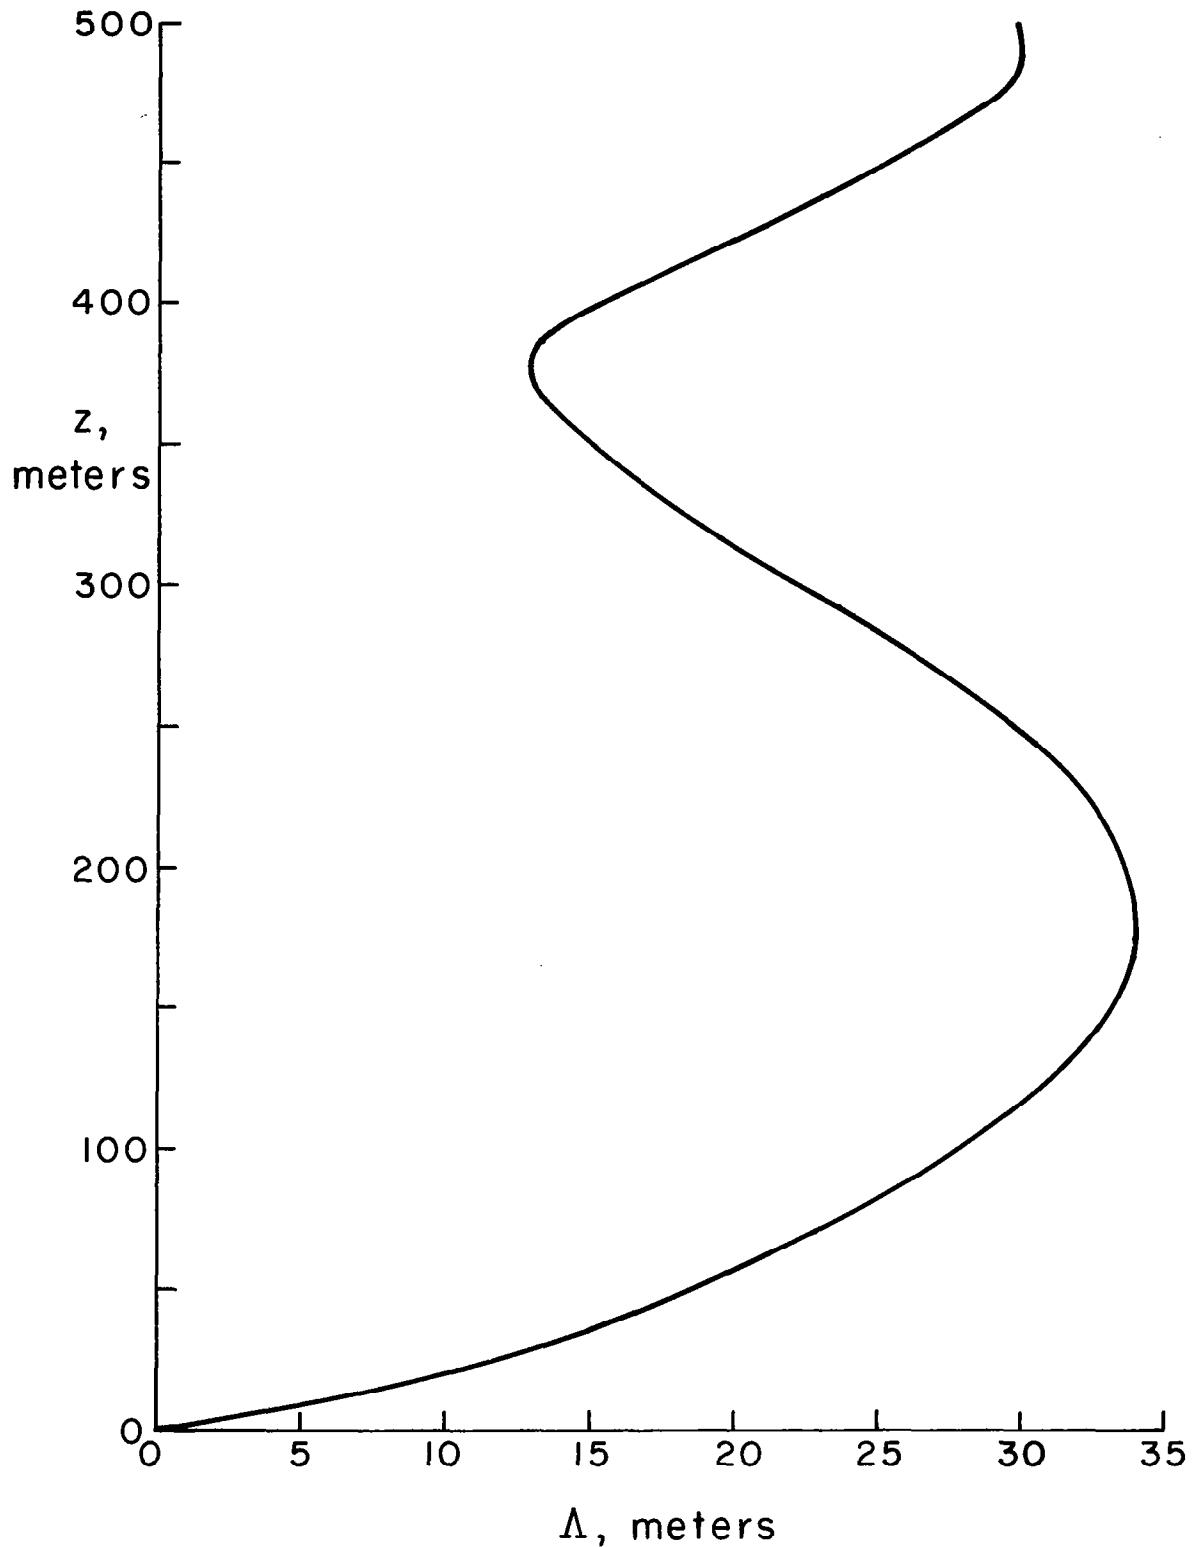
Figure 3.4.13. Altitude profile of scale of turbulence for Wichita, Kansas, March 3, 1973 accident.

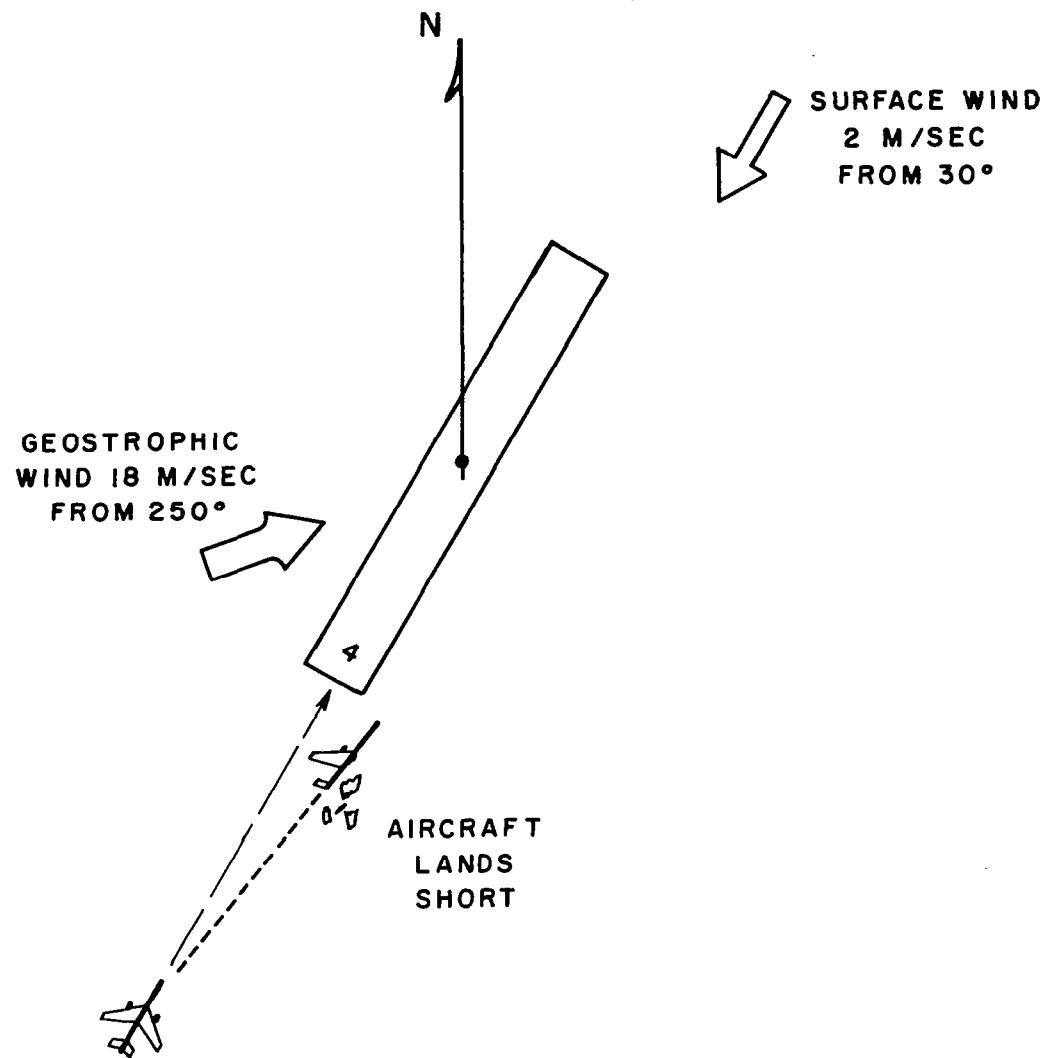
Figure 3.5.1. Aircraft-runway-winds orientation diagram for JFK Airport, December 12, 1972 accident.

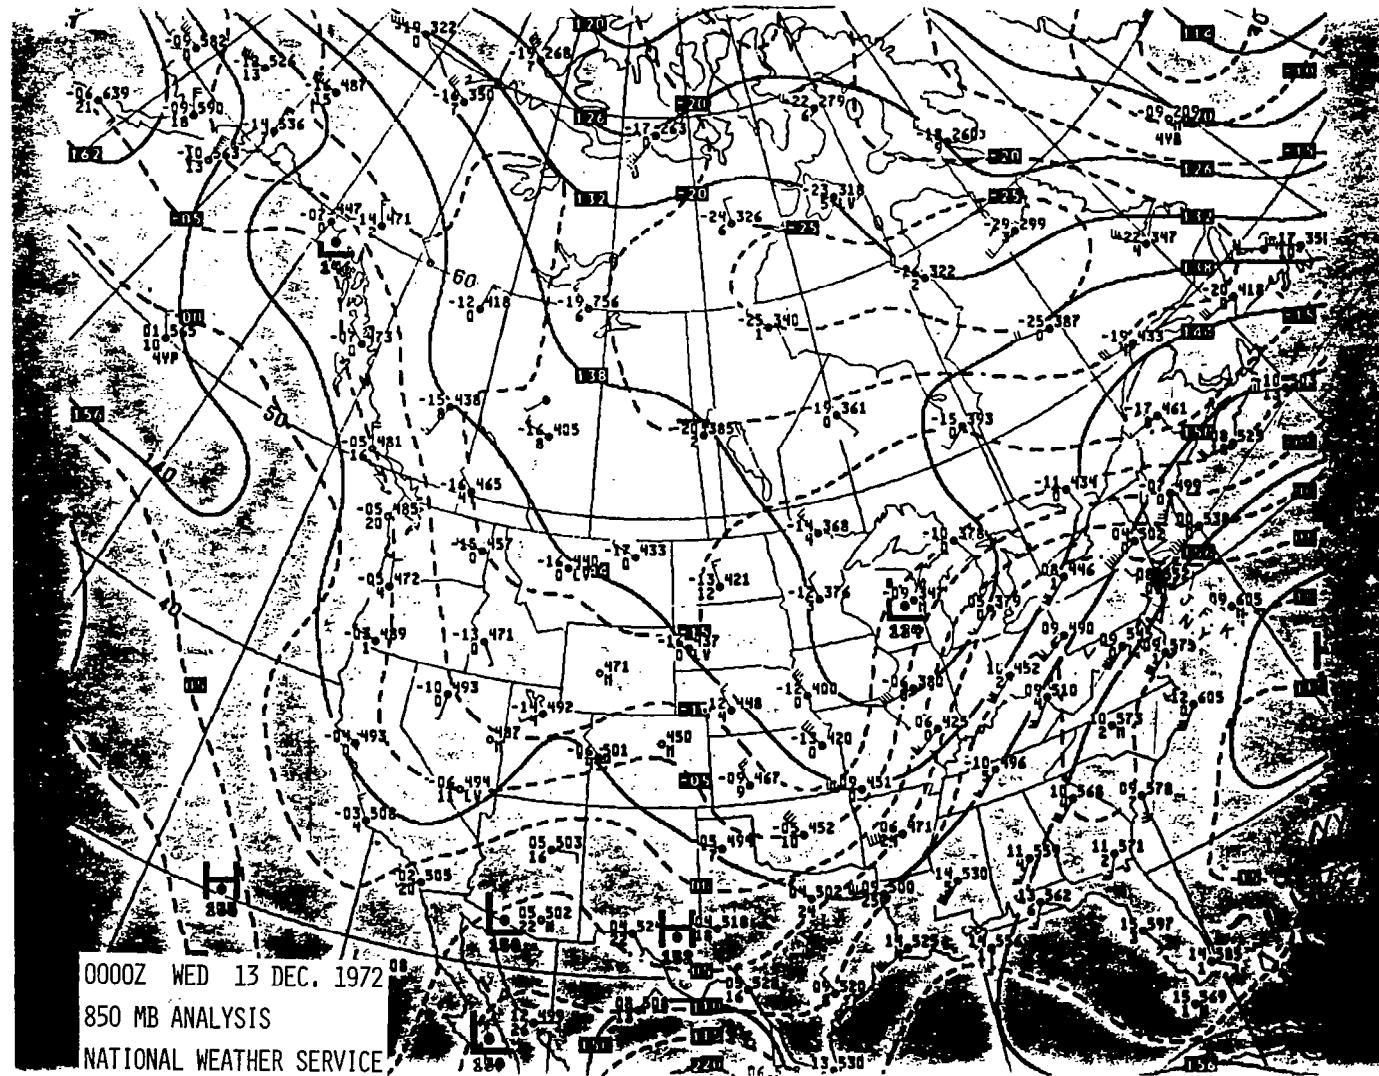
Figure 3.5.3. Late 850 mb chart for JFK Airport, December 12, 1972 accident.

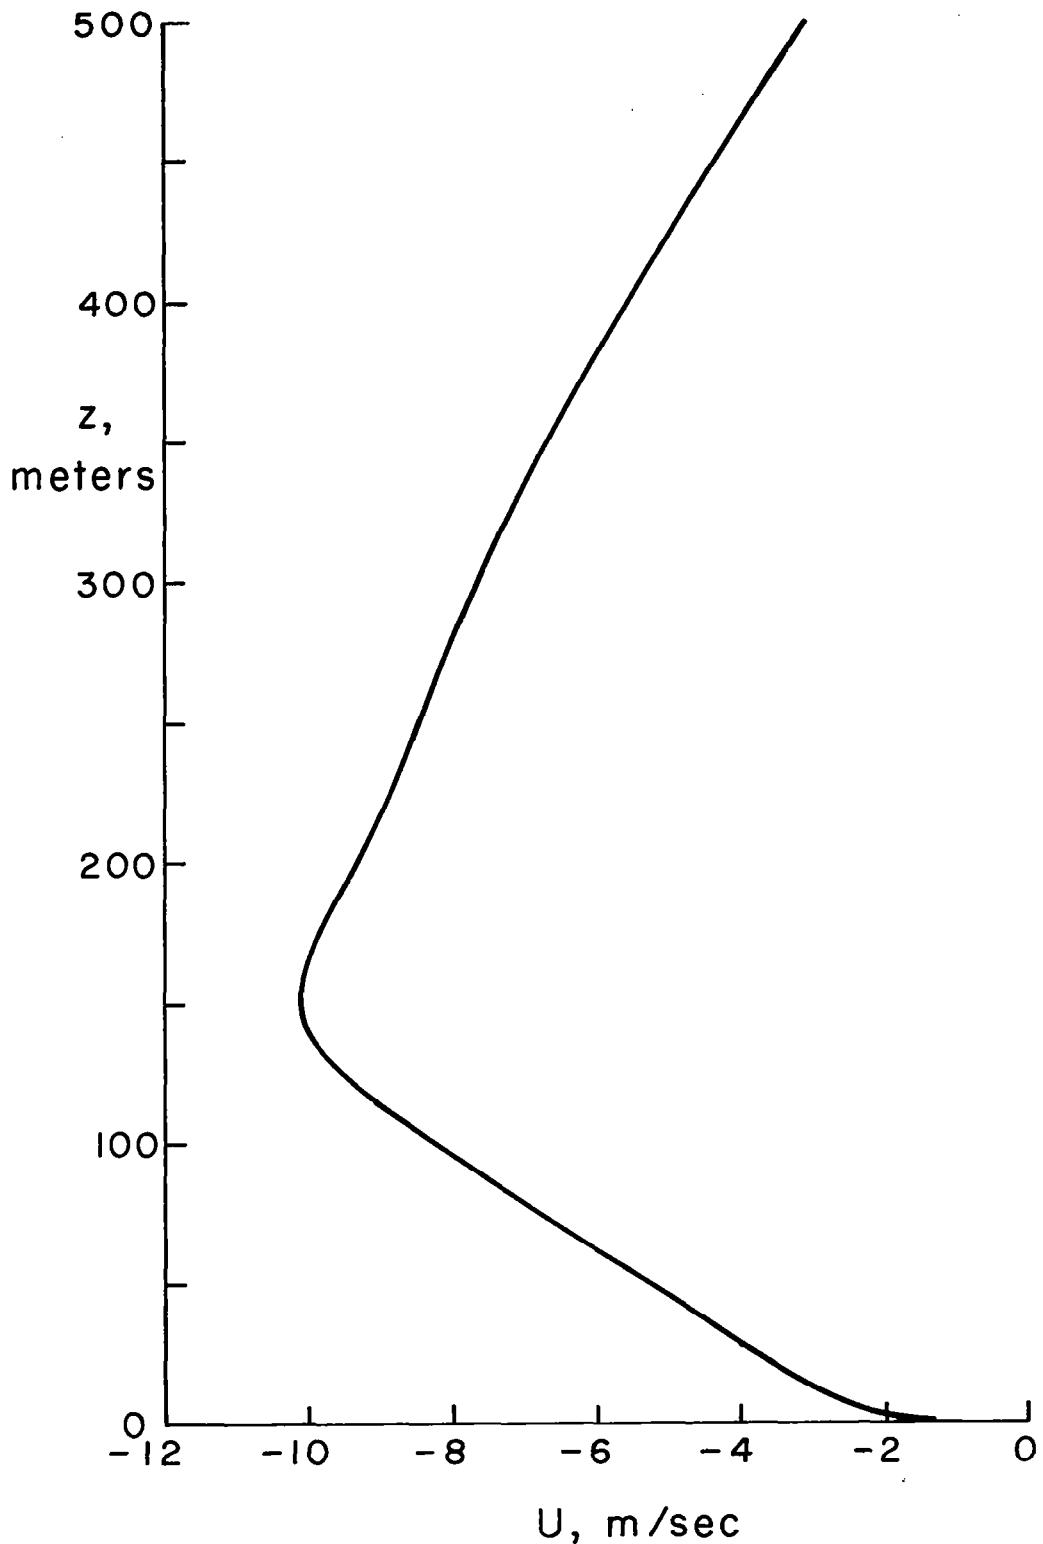
Figure 3.5.7. Altitude profile of mean velocity component parallel to runway (+  $U$ , tailwind) for the JFK Airport, December 12, 1972 accident.

The flight data was recorded normally but was not used to estimate wind profiles. The resulting velocity profile (figure 3.5.7) indicates that the strong tailwind aloft increases to a 10 m/sec headwind down at 140 m. From here on down the headwind drops off to 2 m/sec at ground level which could present problems if timely corrections were not applied. The wind estimate at the 10 m altitude is 2.7 m/sec from  $40^{\circ}$  as compared with an observed value of 2 m/sec from  $40^{\circ}$ . The estimated crosswind and turbulence distributions are not large enough to be hazardous for flight operation (figures 3.5.8 - 3.5.13).

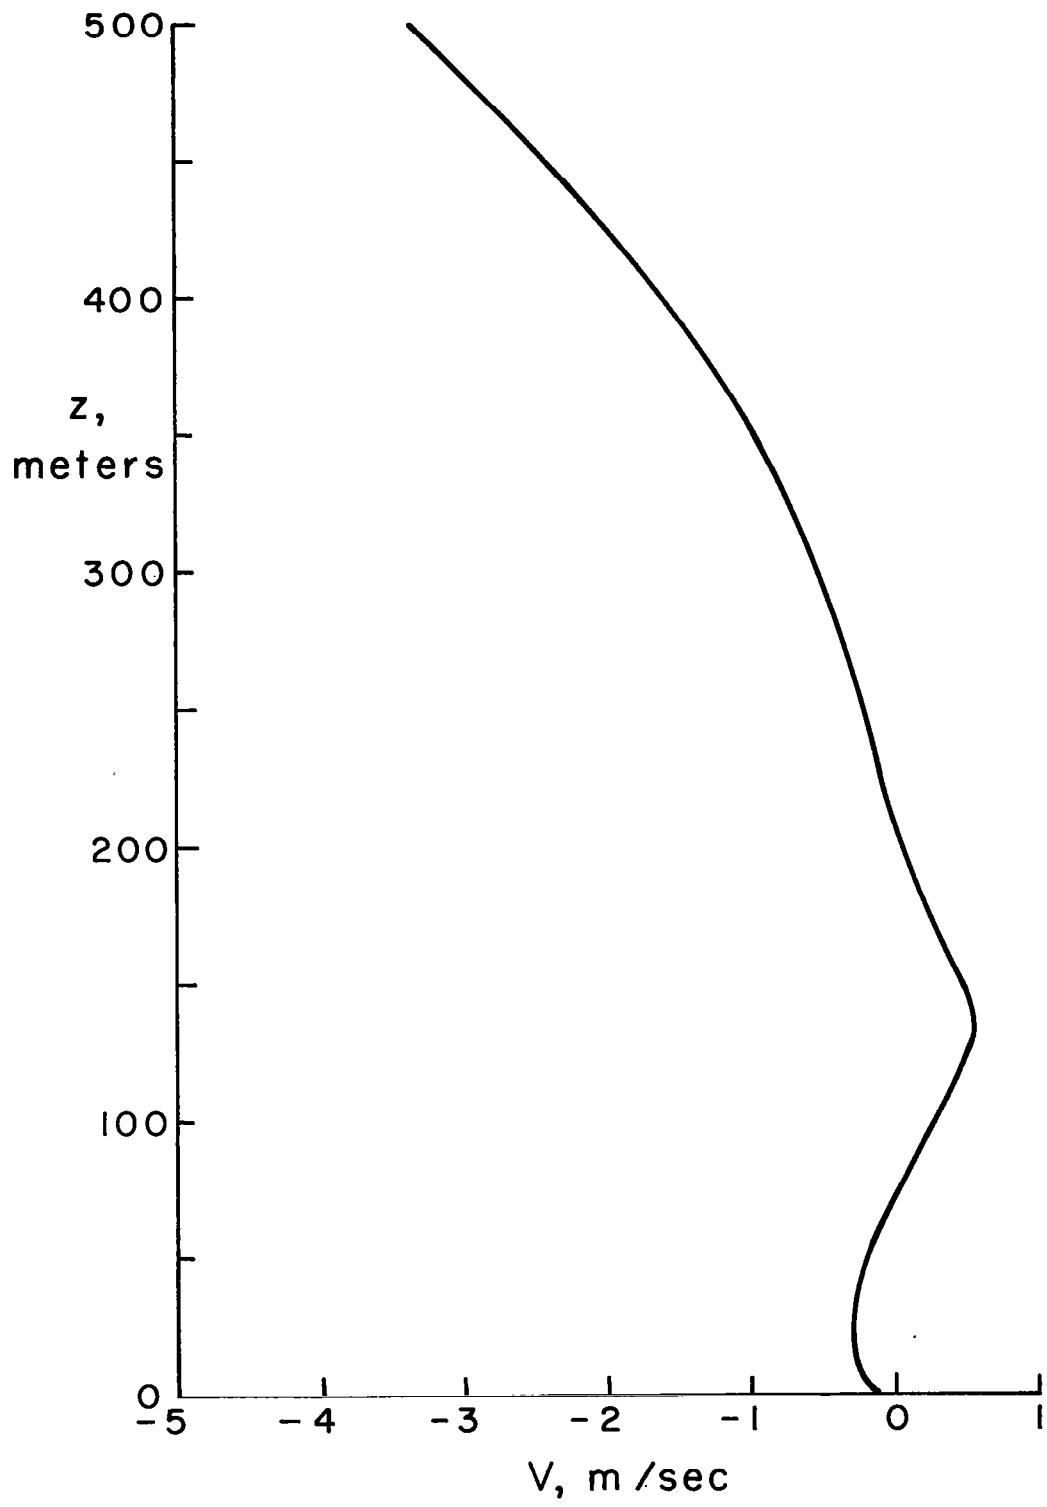
Figure 3.5.8. Altitude profile of mean wind velocity component perpendicular to runway (+  $V$ , crosswind from right) for the JFK airport, December 12, 1972 accident.
